**DEPARTMENT OF TRANSPORTATION**

Quality Assurance and Source Inspection

Contract #: 04-0120F4Cty: SF/ALA Rte: 80 PM: 13.2/13.9File #: 69.28**WELDING INSPECTION REPORT****Resident Engineer:**Pursell, Gary**Address:** 333 Burma Road**City:** Oakland, CA 94607**Report No:** WIR-011689**Date Inspected:** 25-Jan-2010**Project Name:** SAS Superstructure**OSM Arrival Time:** 645**Prime Contractor:** American Bridge/Fluor Enterprises, a JV**OSM Departure Time:** 1845**Contractor:** Zhenhua Port Machinery Company, Ltd (ZPMC), Changxing Island **Location:** Shanghai, China**CWI Name:** Liu Fawen**CWI Present:** Yes No**Inspected CWI report:** Yes No N/A**Rod Oven in Use:** Yes No N/A**Electrode to specification:** Yes No N/A**Weld Procedures Followed:** Yes No N/A**Qualified Welders:** Yes No N/A**Verified Joint Fit-up:** Yes No N/A**Approved Drawings:** Yes No N/A**Approved WPS:** Yes No N/A**Delayed / Cancelled:** Yes No N/A**Bridge No:** 34-0006**Component:** Orthotropic Box Girder (OBG) Components**Summary of Items Observed:**

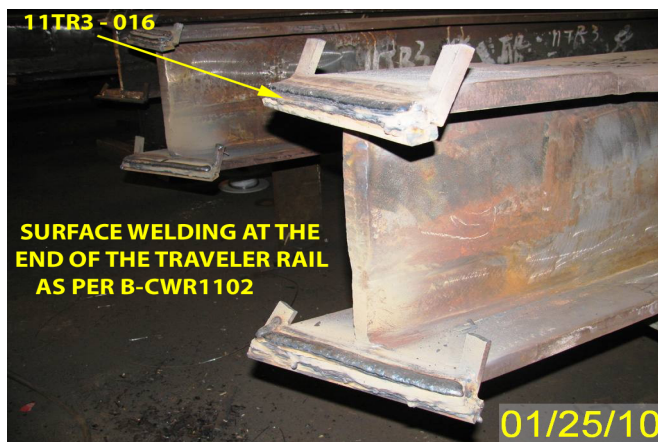
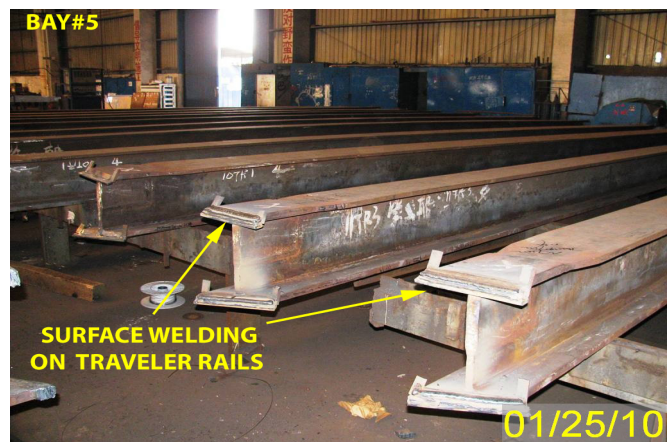
Surface welding being carried out according to Critical weld repair (CWR) report #B-CWR1102 located on Traveler Rail 11TR3 – 016. Welder is identified as 215689. ZPMC Quality Control (QC) Inspector is identified as Zhong Chong Biao. The welding variables recorded by QC appeared to comply with the WPS-345-FCAW-1G(1F)-Repair-1. (See attached Photo)
